# Shared Values, Shared Success: Remediating Endangered Lamprey Habitat in British Columbia

**ABSTRACT:** Stream remediation was undertaken at two impassable fish obstacles in Morrison Creek in Courtenay, British Columbia. These barriers were identified as impassable to the endangered Morrison Creek lamprey (*Lampetra richardsoni* variety *marifuga*) and a seasonal impediment to the movement of salmonids. The success of this remediation was not only in the removal of barriers to lamprey but in balancing the needs of multiple species of differing and sometimes conflicting habitat requirements. Community engagement was also a key outcome of the remediation with increased awareness of the protected lamprey species, hands-on interaction with stream remediation activities and the interaction and cooperation with landowners. What remains to be determined is if these remediation activities can slow or reverse the decline observed in catches of Morrison Creek lamprey.

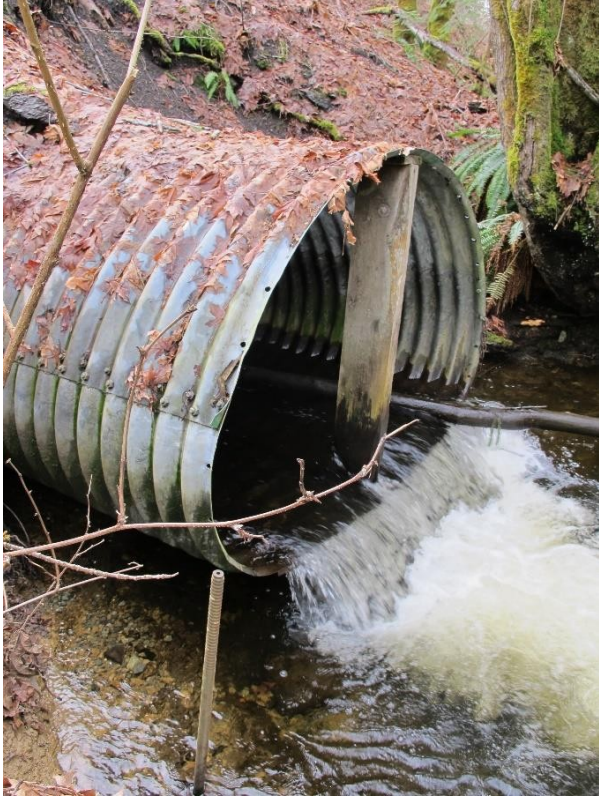
**Figure 1:** Photograph of impassable barriers to Morrison Creek lamprey taken in spring 2013.

Pictured left: Hung-culvert

Two barriers, a hung culvert and a defunct salmon weir (Figure 1a, b respectively) were identified as impassable by Morrison Creek lamprey (Wade & Beamish 2014). Because these lamprey reside in an environment which is important to multiple species which would benefit from remediation of these barriers, funding was requested from various

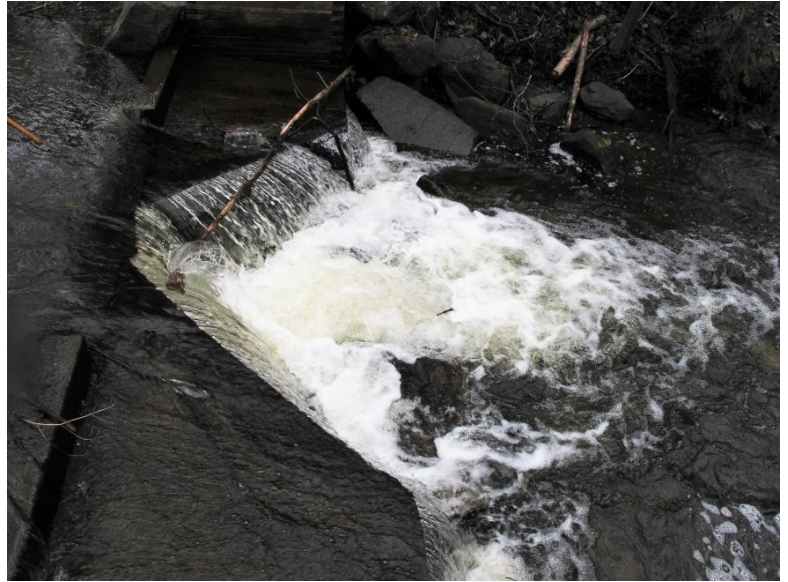
Pictured right: Defunct salmon weir

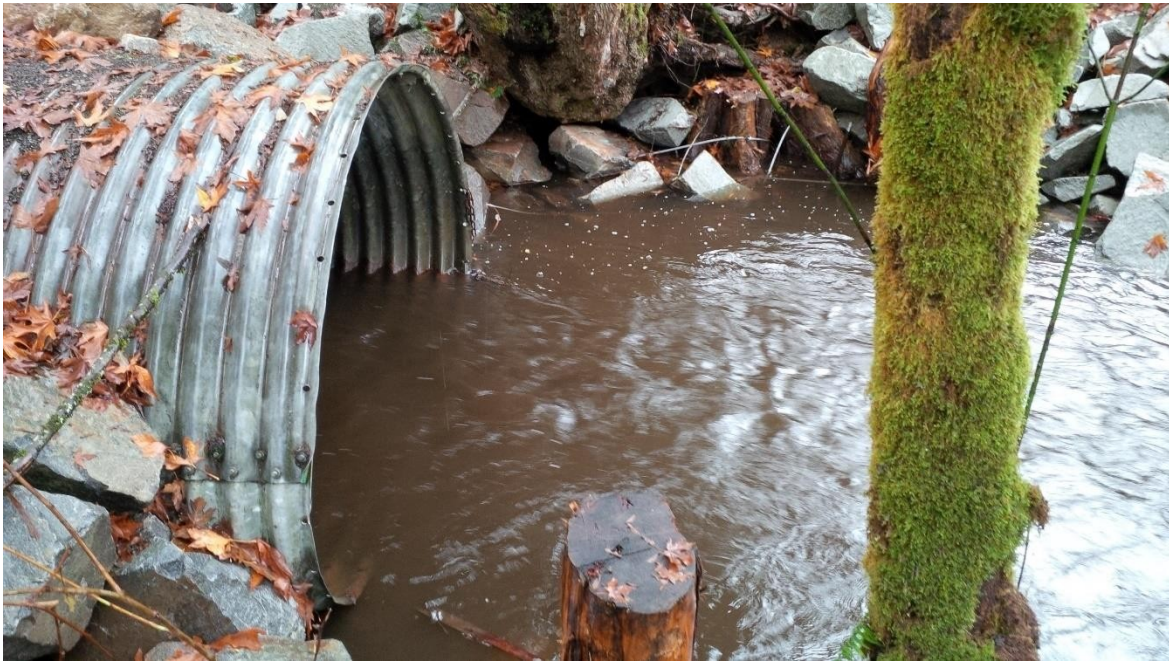
**Figure 2:** Photographs of remediated areas of Morrison Creek (fall 2015).

Picture above: Remediated culvert

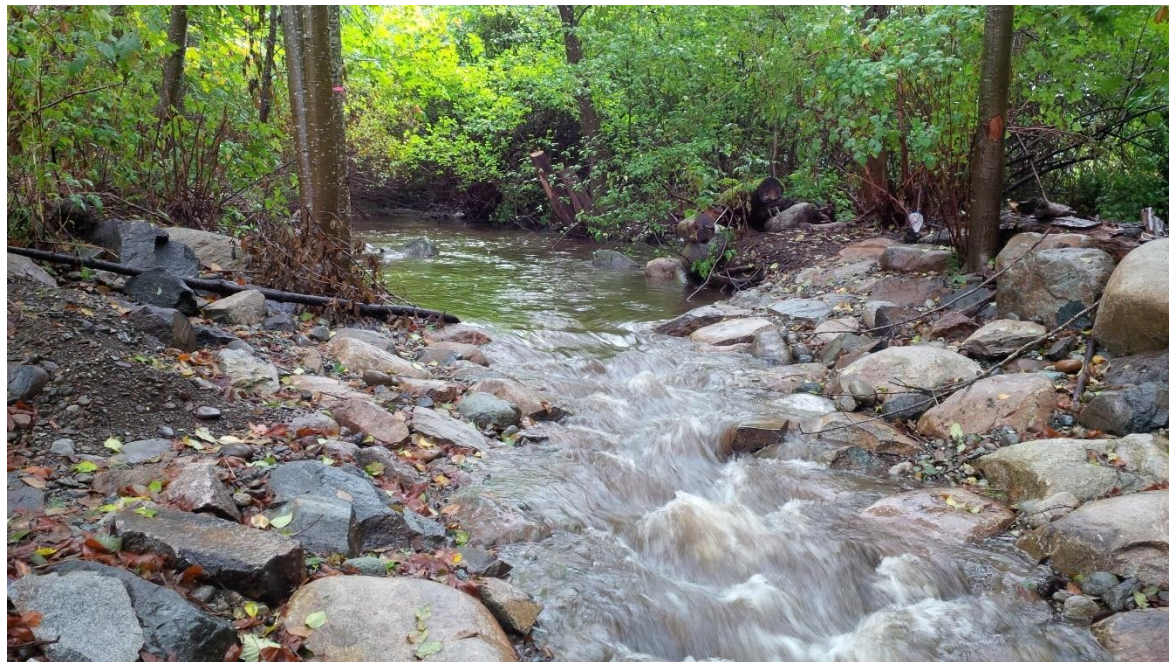
Picture below: Remediated location of salmon weir.
